Town of Rowley

Bridge Inventory Evaluation

JUNE 2019

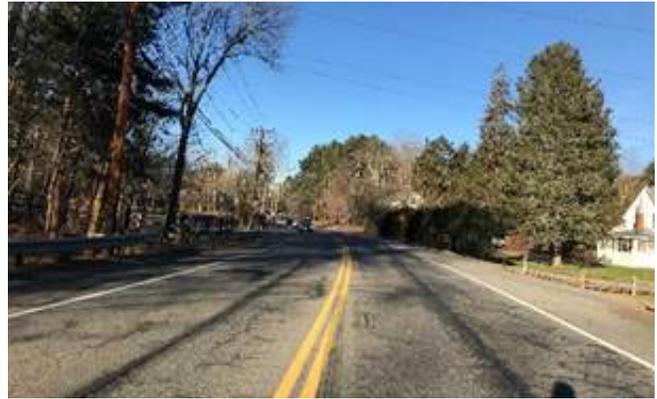
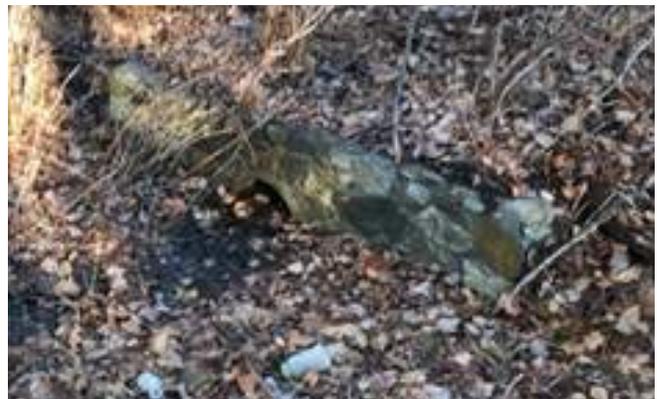
46. Haverhill Street (908)

BRIDGE TYPE	Single culvert with concrete pipe
WEARING SURFACE	Asphalt
RAILING TYPE	
UPSTREAM	Metal guardrail
DOWNSTREAM	Metal guardrail
OVERALL CONDITION	6
NOTES:	Upstream (N) portal is submerged in water; headwall fair; downstream pipe is about 1/2 full of heavy debris.
IMMEDIATE NEEDS	Clean debris from pipe and DS channel.

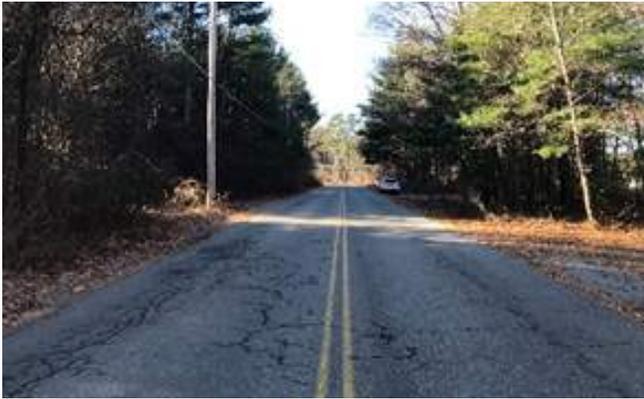
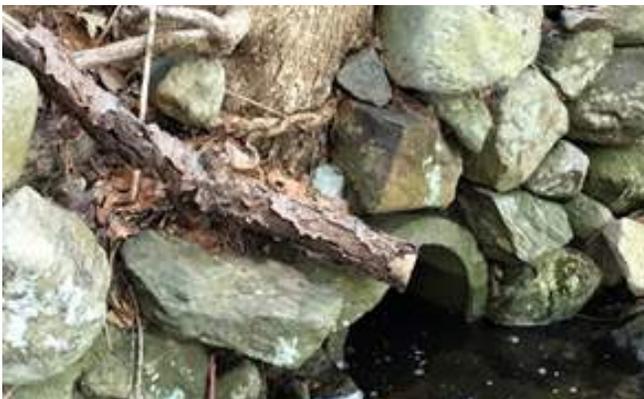
47. Boxford Road (139)

BRIDGE TYPE	Single culvert with concrete pipe
WEARING SURFACE	Asphalt
RAILING TYPE	
UPSTREAM	None
DOWNSTREAM	None
OVERALL CONDITION	5
NOTES:	DS Stone headwall has large tree and roots growing over it.
IMMEDIATE NEEDS	Remove tree at DS headwall and re-set stones. Clean channel of debris.

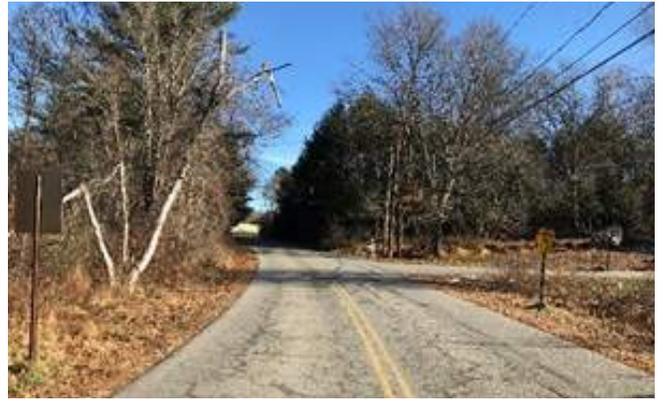
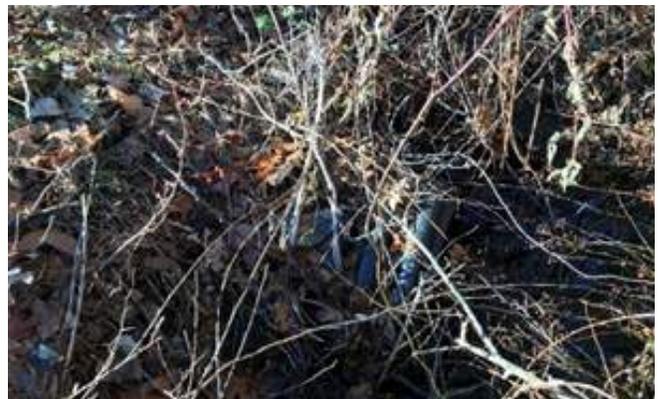
48. Boxford Road (151)

BRIDGE TYPE	Single culvert with poly pipe
WEARING SURFACE	Asphalt
RAILING TYPE	
UPSTREAM	None
DOWNSTREAM	None
OVERALL CONDITION	6
NOTES:	Pipe is in a good condition, no headwall downstream.; upstream headwall meets satisfactory.
IMMEDIATE NEEDS	Clear vegetation and debris. Pipe is in a good condition, no headwall downstream.; upstream headwall meets satisfactory.

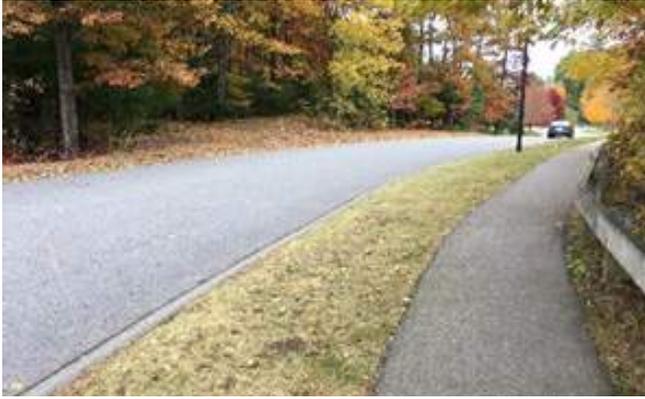
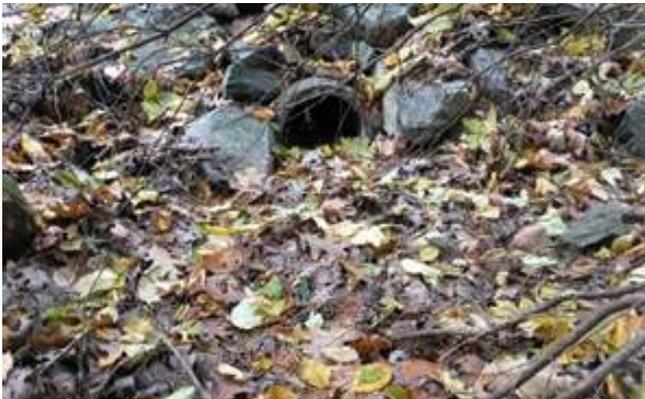
49. Wilkes Road (5)

BRIDGE TYPE	Single culvert with concrete pipe
WEARING SURFACE	Asphalt
RAILING TYPE	
UPSTREAM	None
DOWNSTREAM	Wood
OVERALL CONDITION	6
NOTES:	Debris appears at inlet and no headwall. Stone headwall at outlet. (Dry during field visit)
IMMEDIATE NEEDS	Remove debris from inlet.

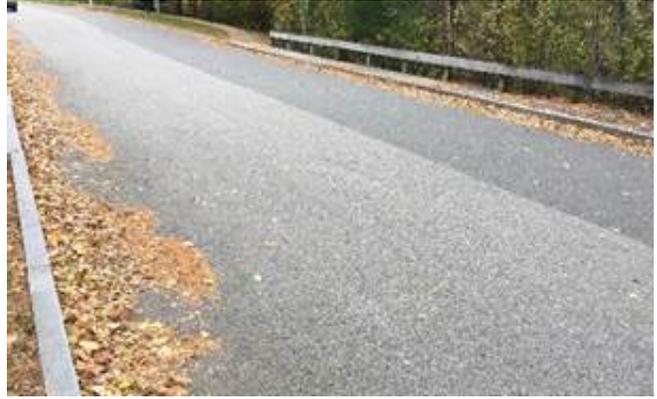
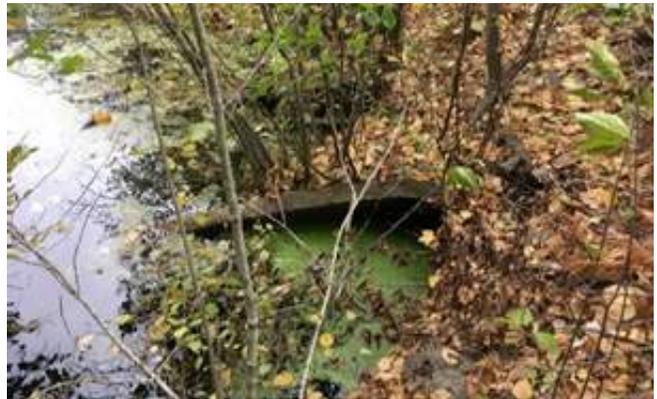
50. Cindy Lane (5)

BRIDGE TYPE	Triple culvert with concrete pipe
WEARING SURFACE	Asphalt
RAILING TYPE	
UPSTREAM	Wood guardrail
DOWNSTREAM	Wood guardrail
OVERALL CONDITION	7
NOTES:	Vegetation growing between pipes and on slopes.
IMMEDIATE NEEDS	Remove vegetation growing between pipes.

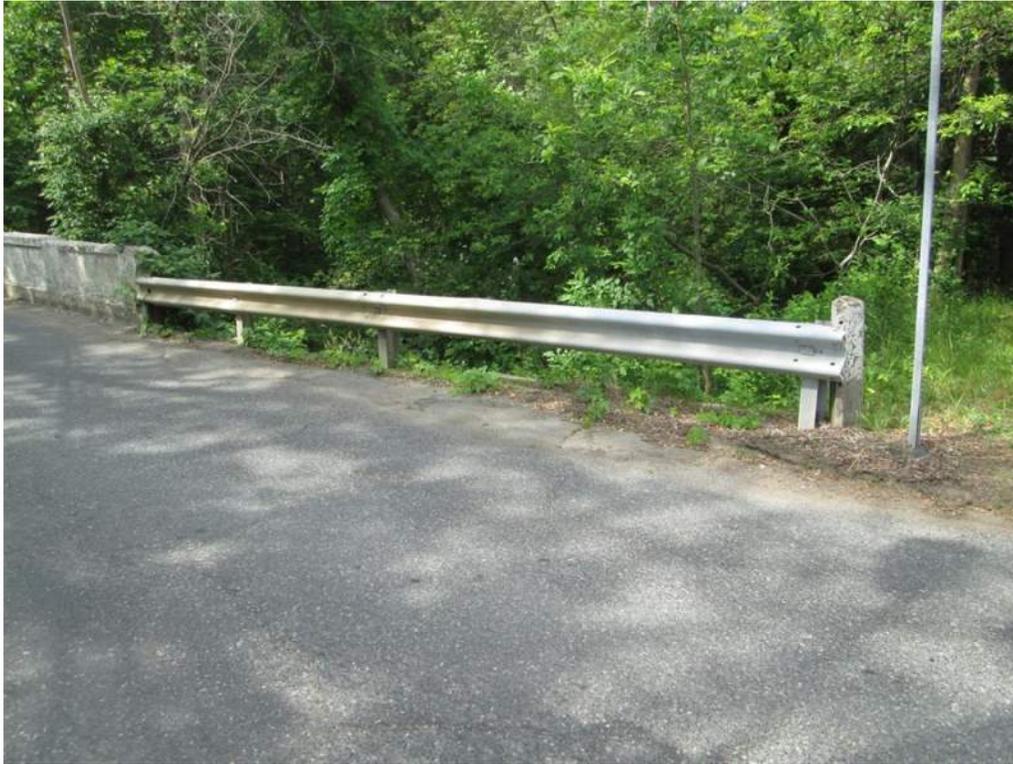
Both Northeast and Northwest transitions do not connect to parapet they are terminated before the parapet with steel posts. (See Photos #19 & #20).

The Northwest approach guardrail end at access road terminates without a proper end condition. (See photo #19)

Photo 19: Northwest Transition Rail Does Not Connect to Bridge Rail (Parapet)

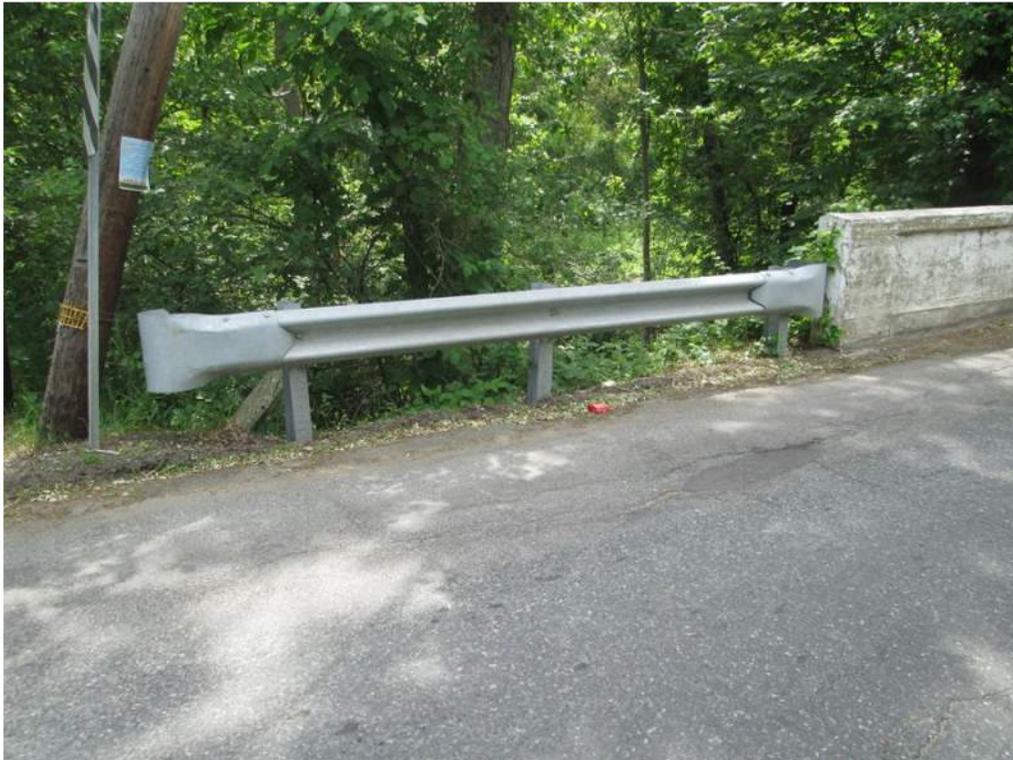
Photo 20: Northeast Transition Rail Does Not Connect with Bridge Rail (Parapet)

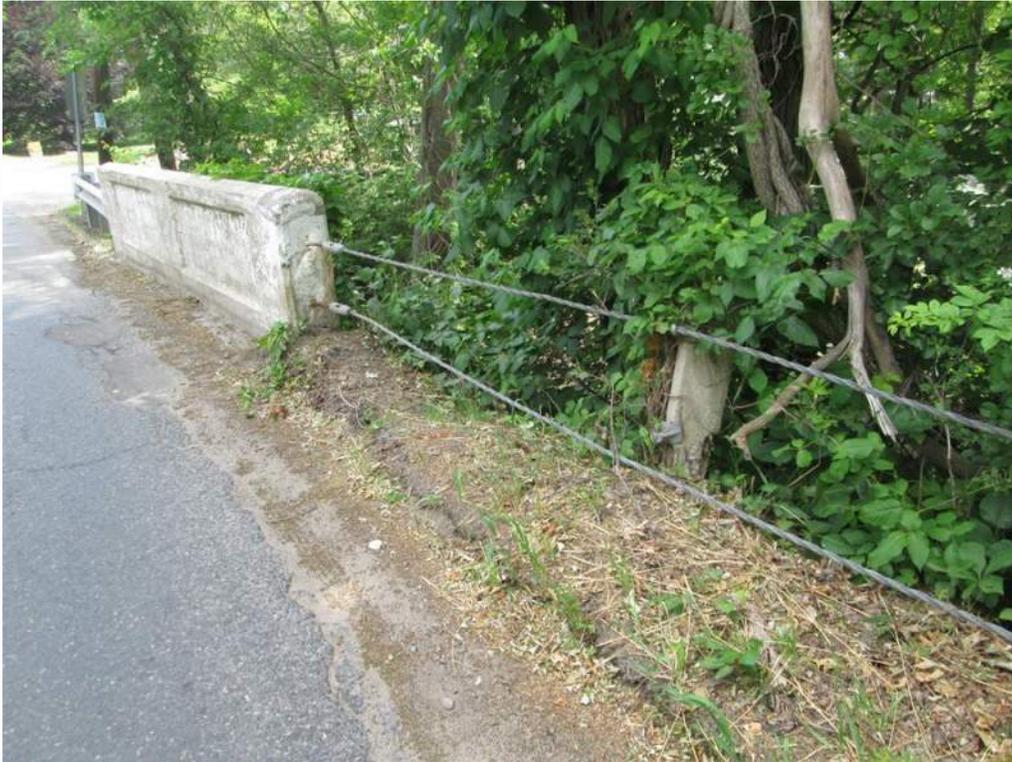
The Southeast and Southwest transition rails are two steel wire cables on concrete posts that are fastened to the bridge rail. (See photo #21)

Photo 21: Southeast Transition Two Steel Wire Transition Rail

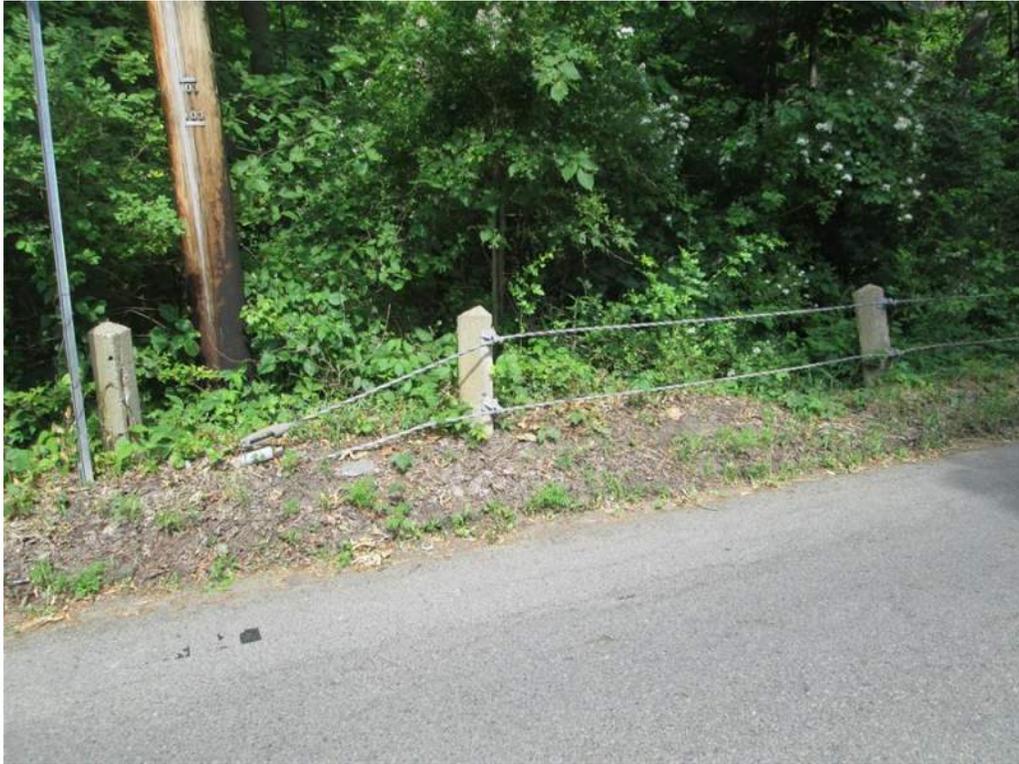
Both the Southeast and Southwest approach guardrail ends are two steel wire cables buried in the ground. See photo #23)

Photo 23: Southwest Approach Two Wire Cable Steel Guardrail Buried End

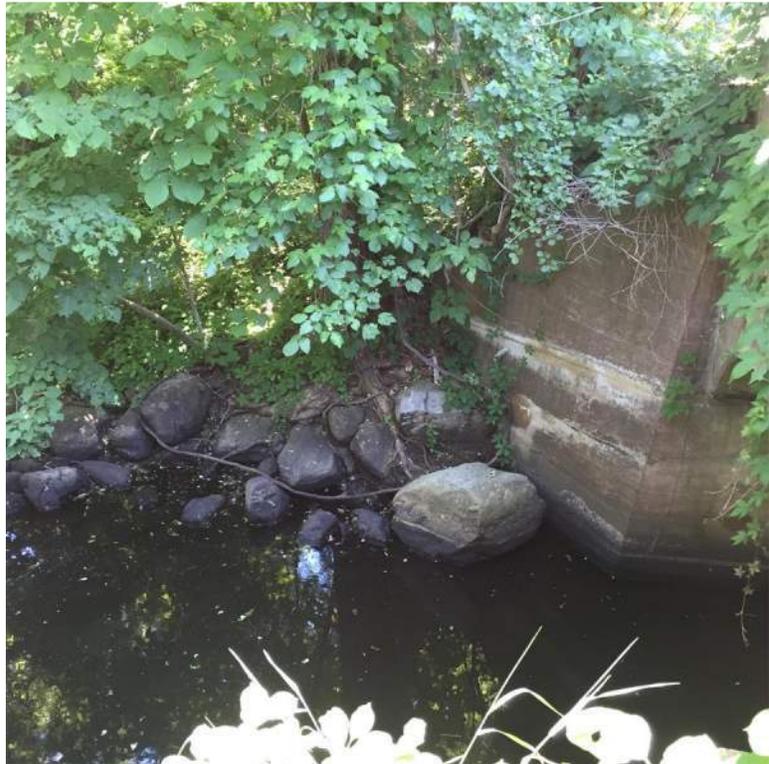
Photo 24: Southeast Wingwall

The Northeast and Southeast wingwalls have cracks at construction joints with moderate efflorescence. See photos #24 & #25)

The Southeast embankment in front of the Southeast wingwall has a tree with its roots fully exposed and very minimal vegetation. (See photo #24)

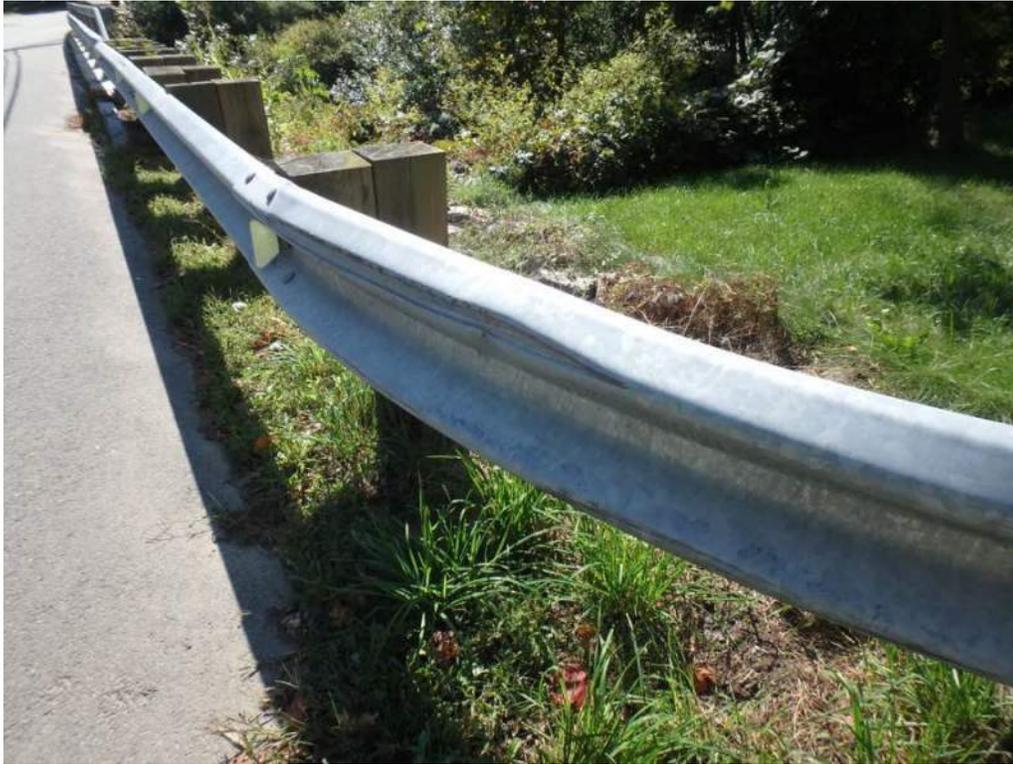
Southwest approach guardrail- Minor scrapes and dents (**Photo 5**).

Photo 5: Southwest approach guardrail minor scrapes and dents.

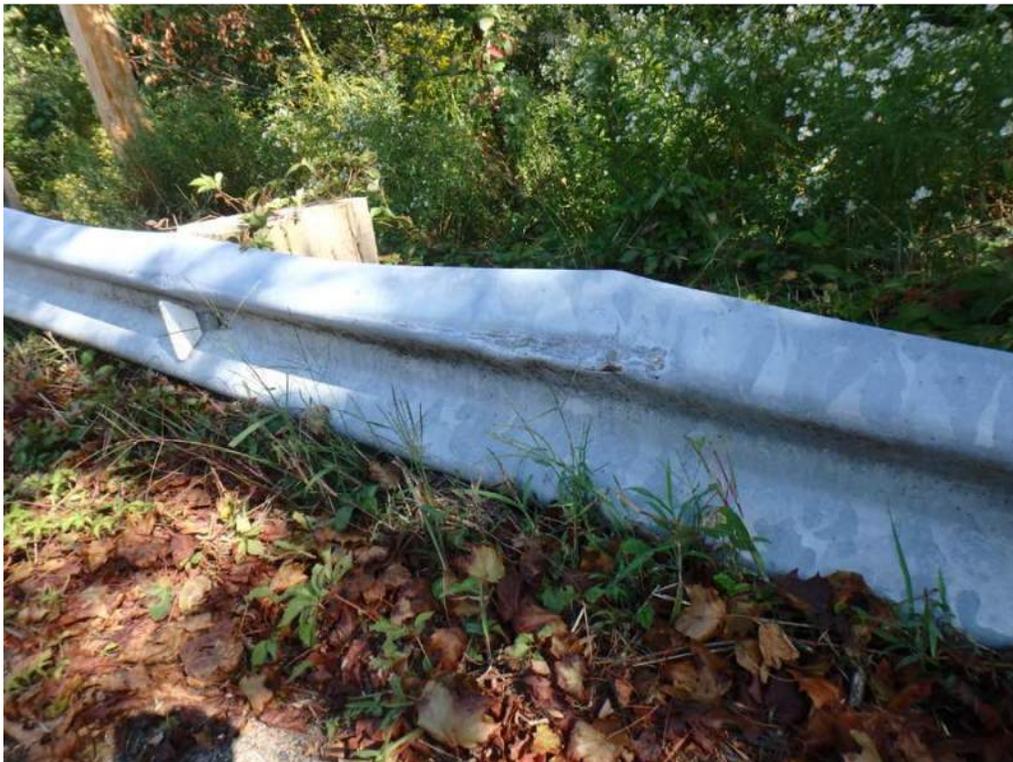
Photo 6: Northeast guardrail has minor scrapes and dents near buried end treatment.

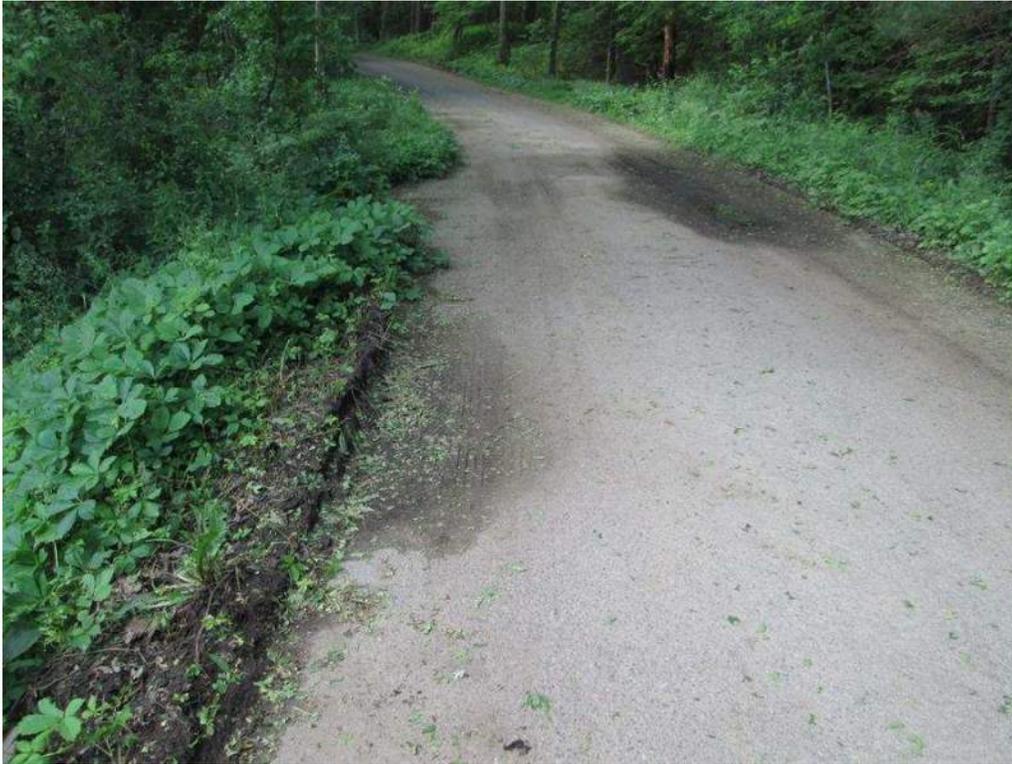
Photo 7: South Approach Pavement Settlement (Looking South) at Southeast Side of Road

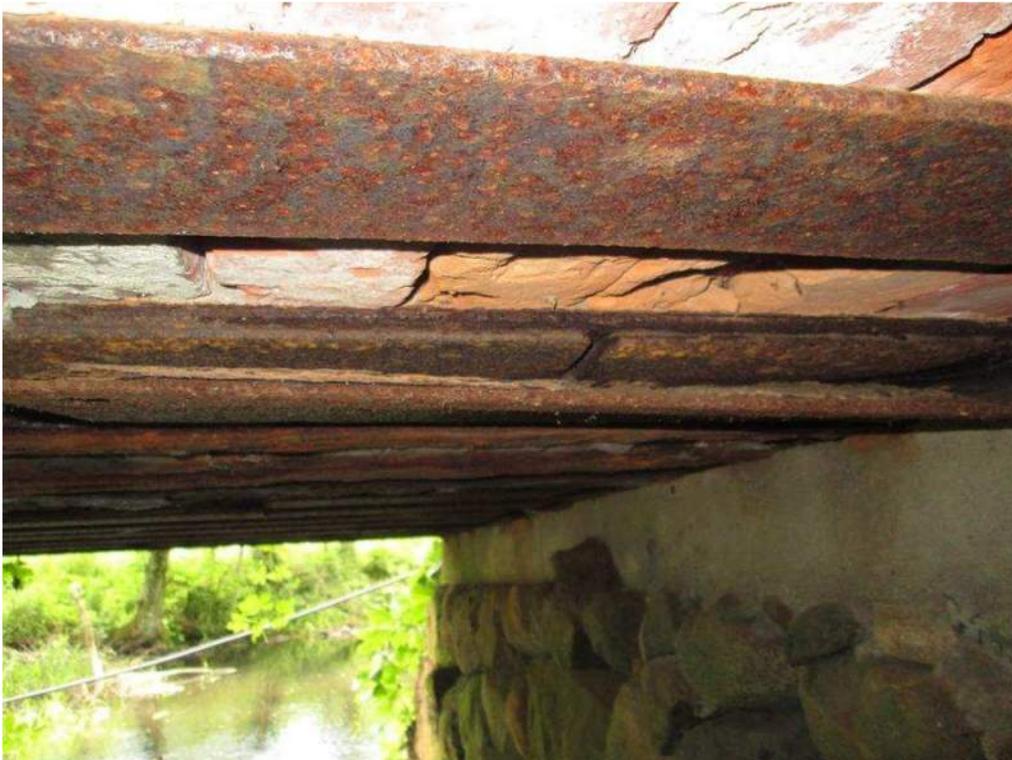
Rail R-9 at the bottom flange has surface rust across the full span with up to 20% loss of bottom flange section. Near the South abutment the rail is spliced with a splice plate. (See photo #12)

Photo 12: Rail R-9 Bottom Flange Splice and Splice Plate

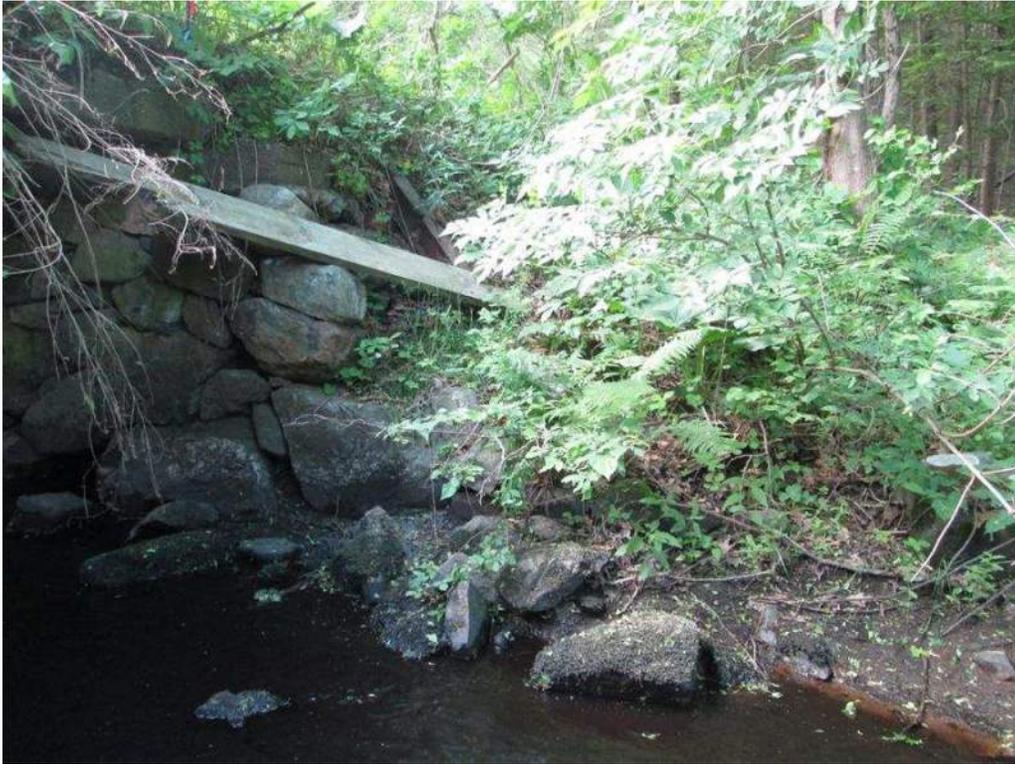
Photo 27: Northeast Wingwall Dislodged Stones

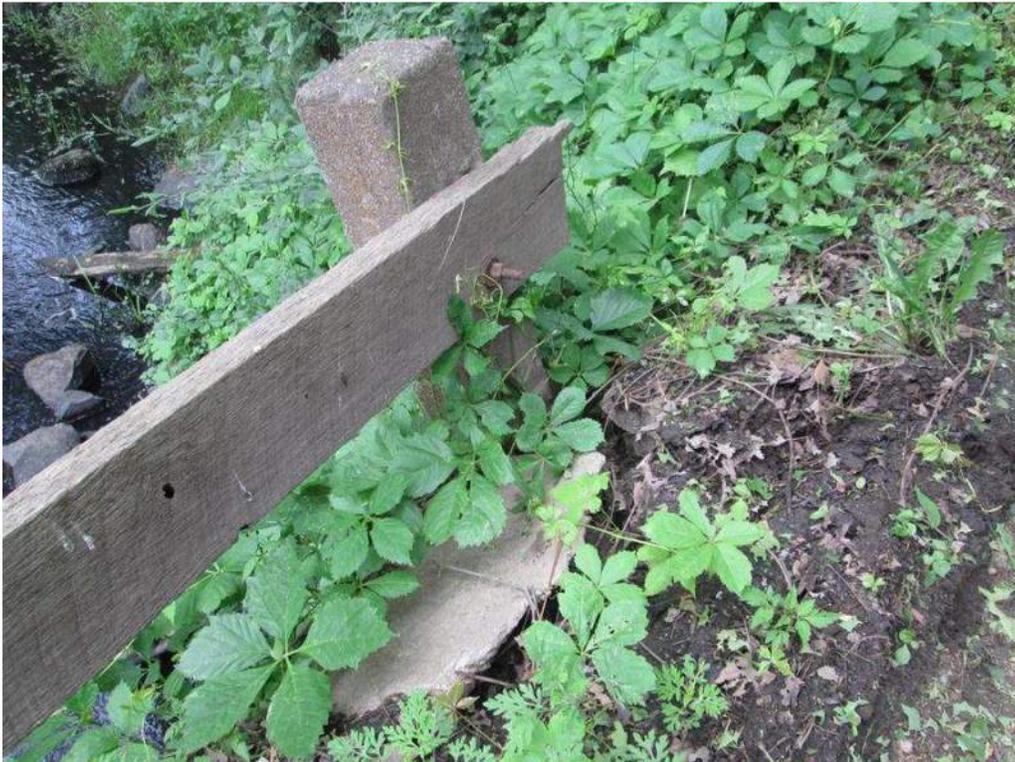
Photo 28: Southeast Bridge Rail Concrete Post Base Separation

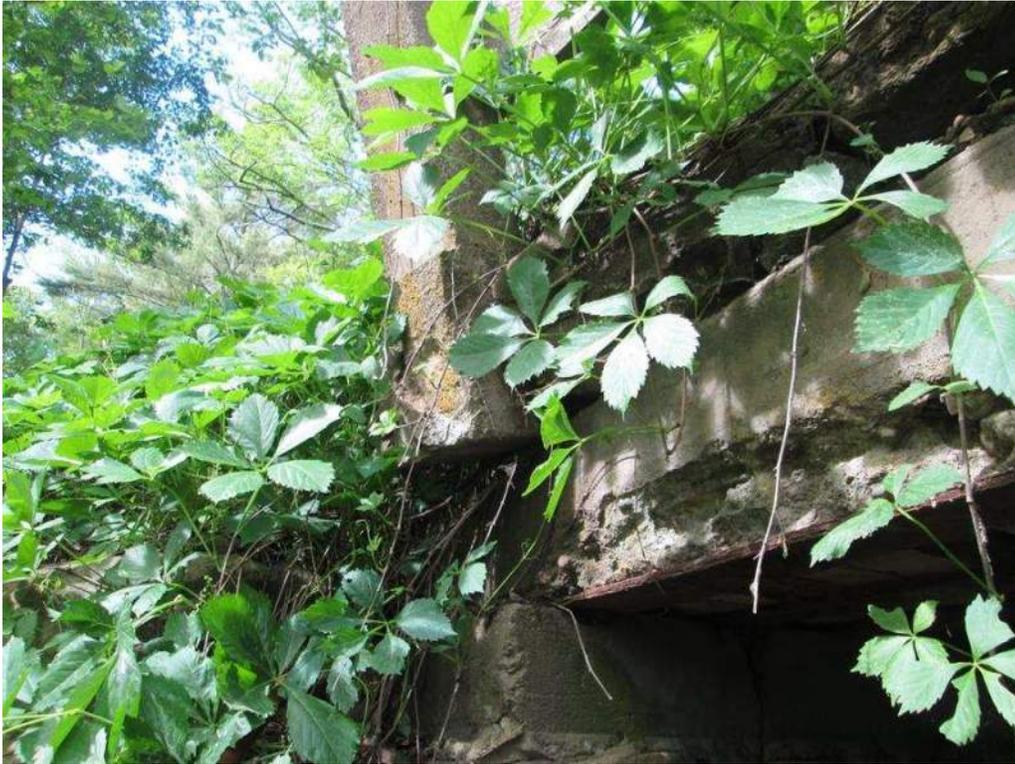
Photo 29: Southeast Bridge Rail Post Overhanging the East Fascia

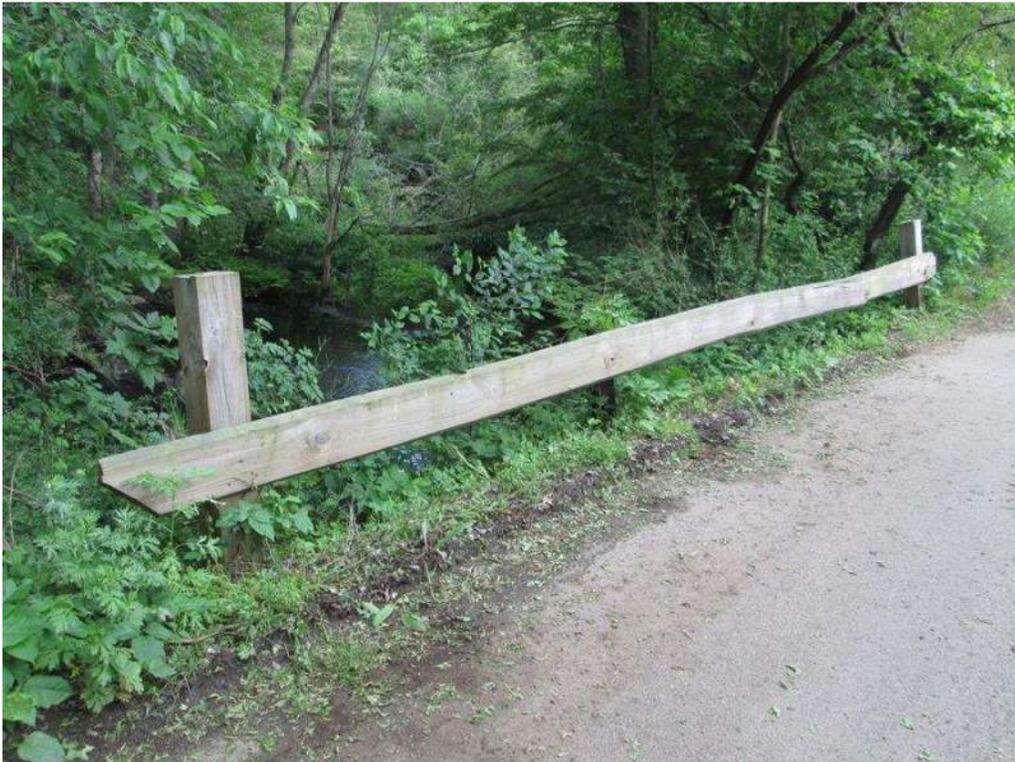
Photo 30: West Bridge Rail Span Over Bridge Without Posts on Bridge

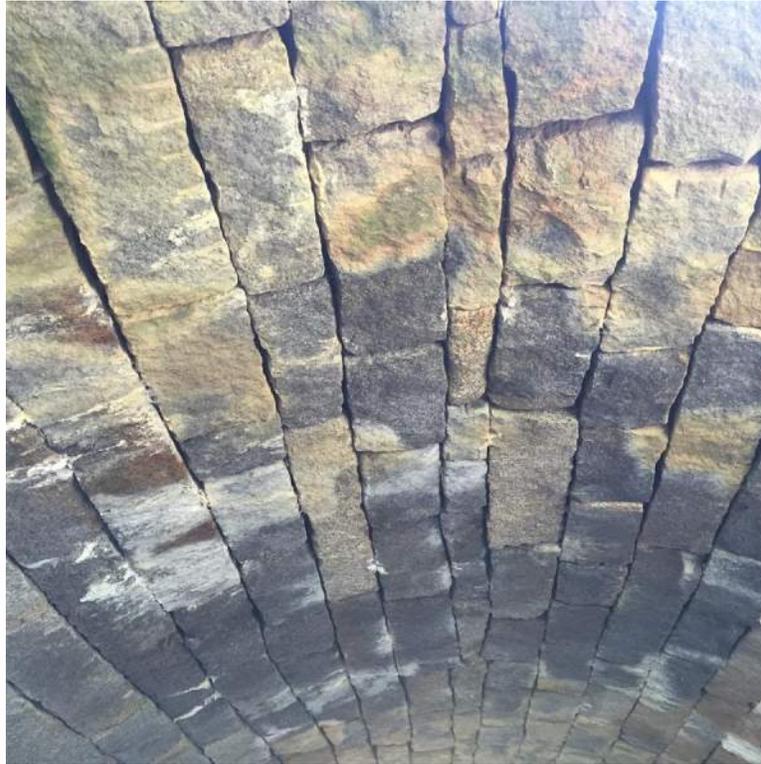
Photo 1: Arch Crown Underside Exposed Efflorescence

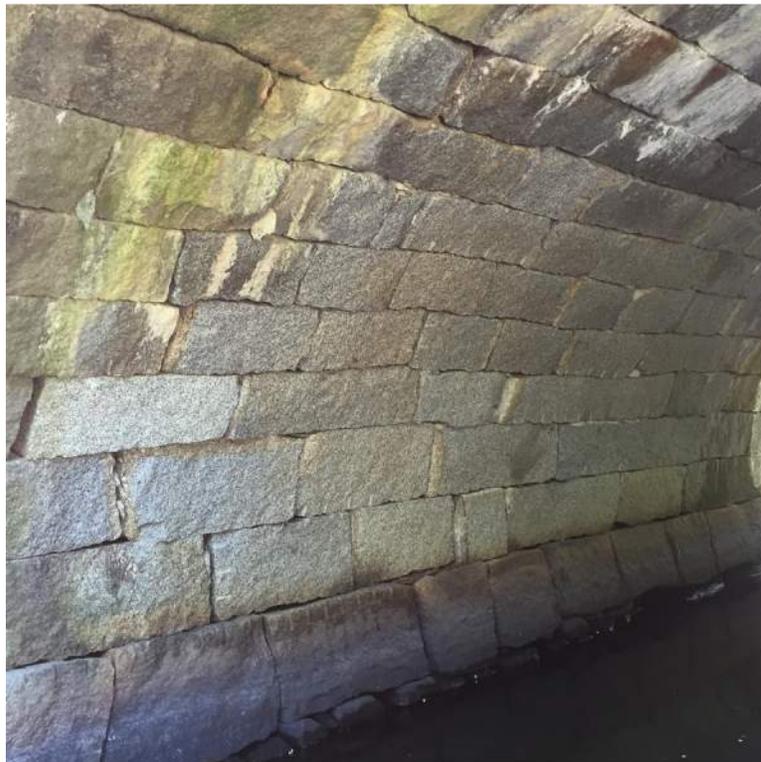
Photo 2: Underside of Arch (Easterly End)

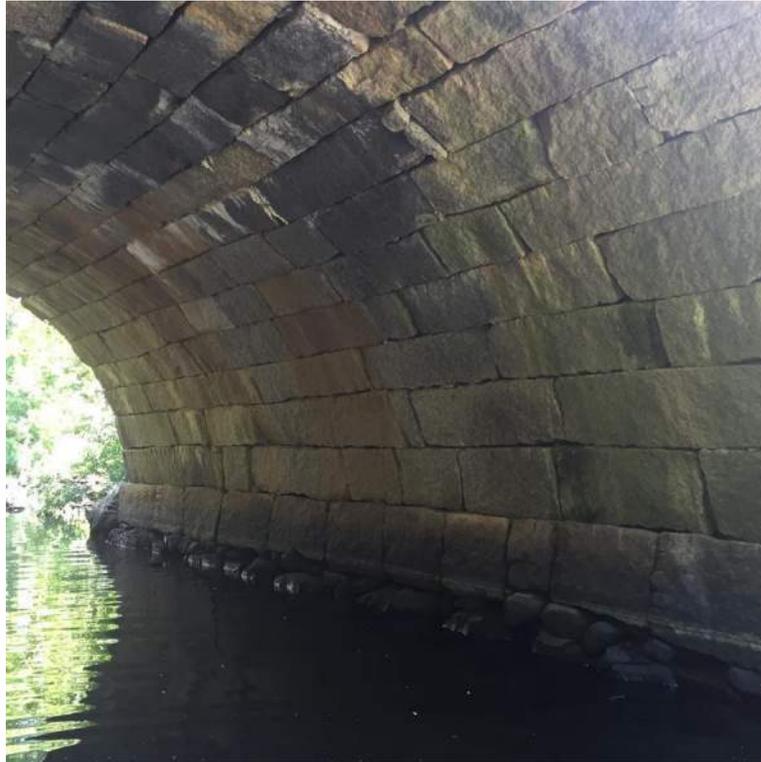
Photo 3: Underside of Arch (Westerly Side)

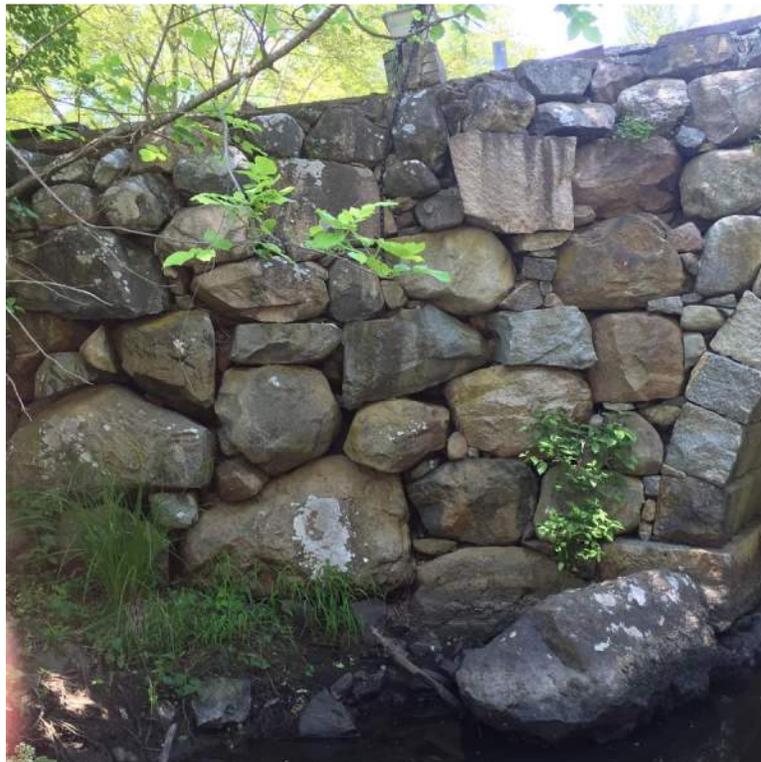
Photo 4: Typical Wingwall Condition

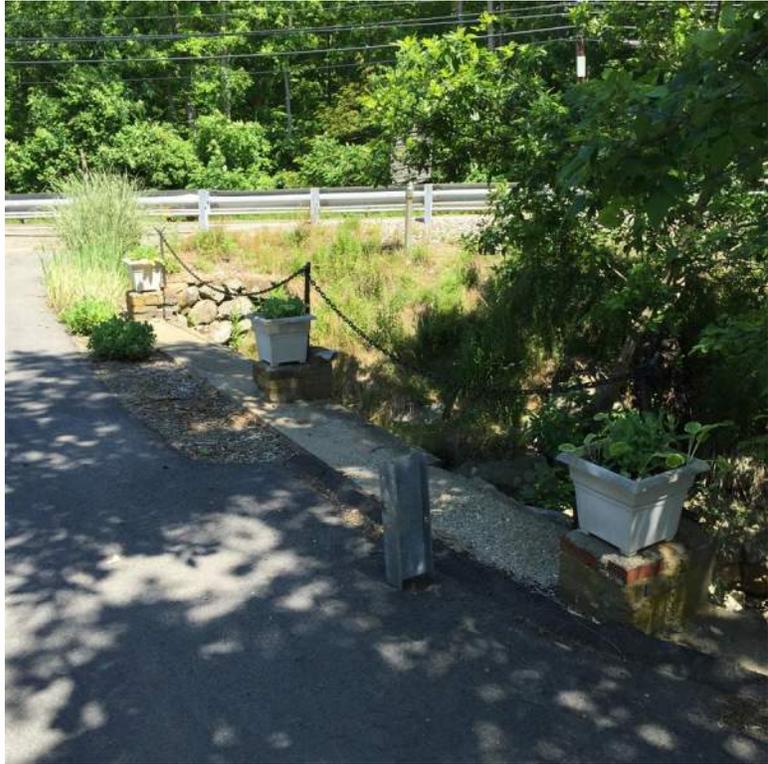
Photo 5: South Bridge Rail

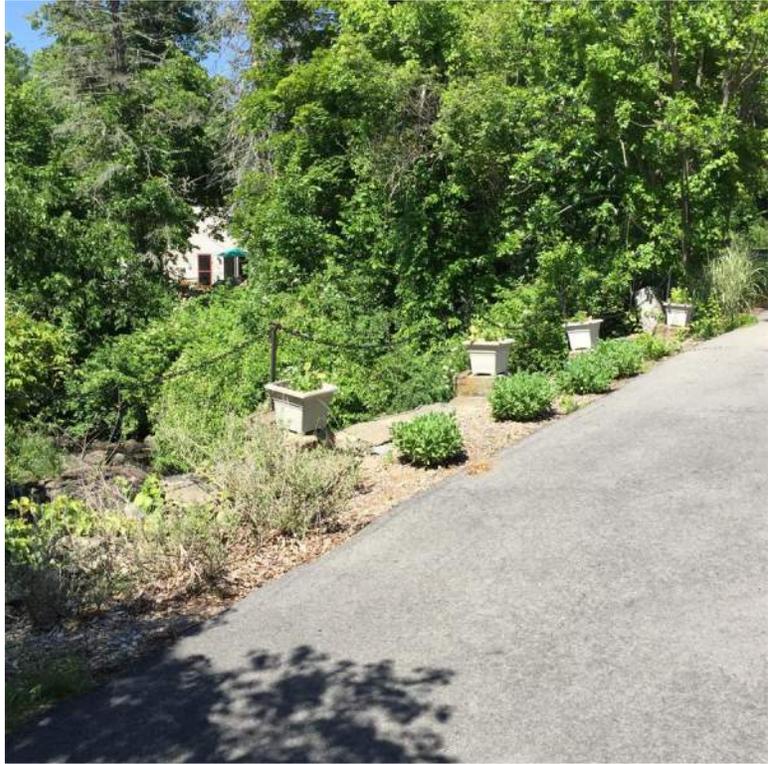
Photo 6: North Bridge Rail

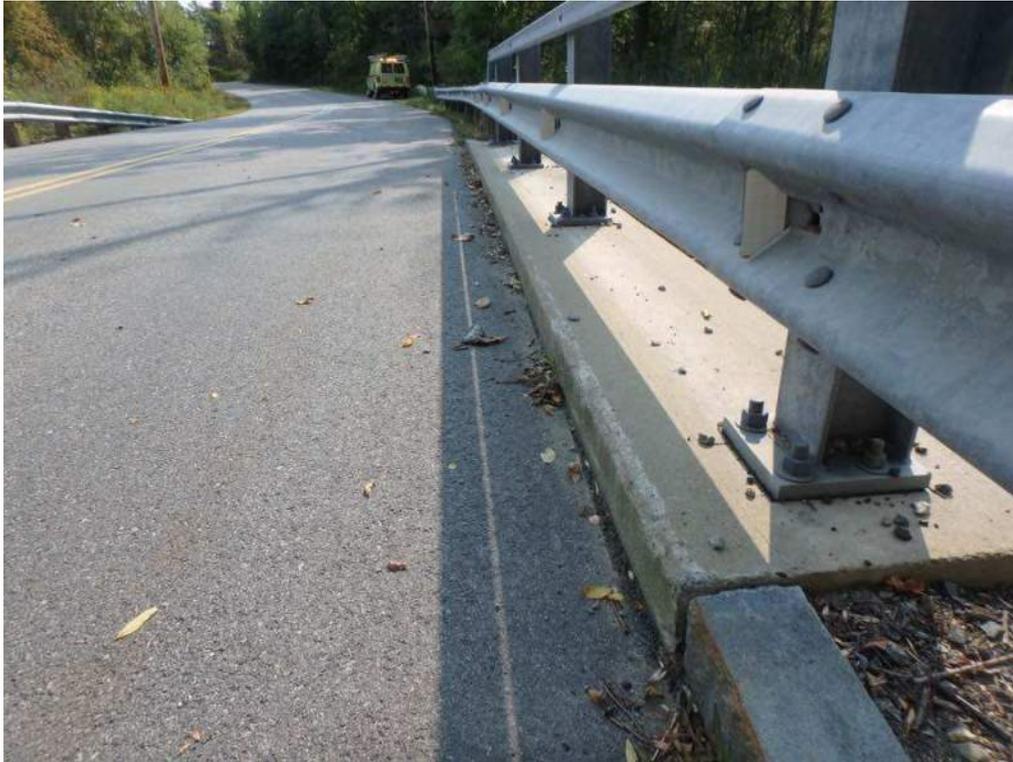
Photo 1: South curb has minor scrapes throughout

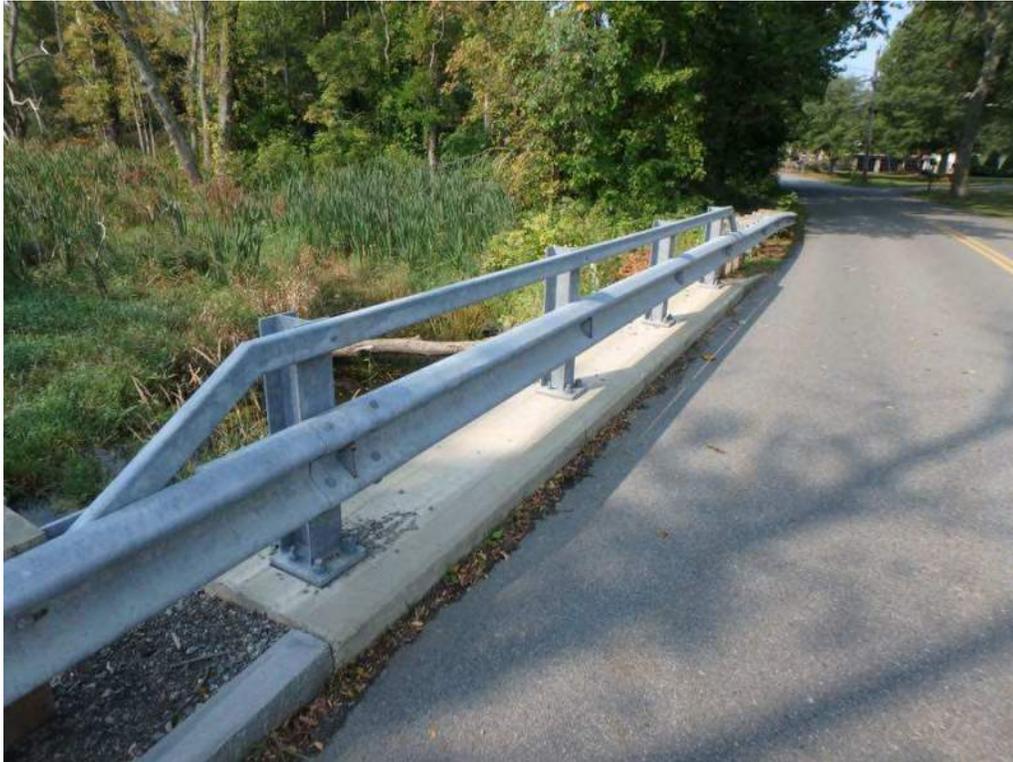
Photo 7: Type T101 modified bridge railing; Typical.
